**MECHANICAL**

*Existing Facility Evaluation*

**ELECTRICAL**

**PLUMBING**

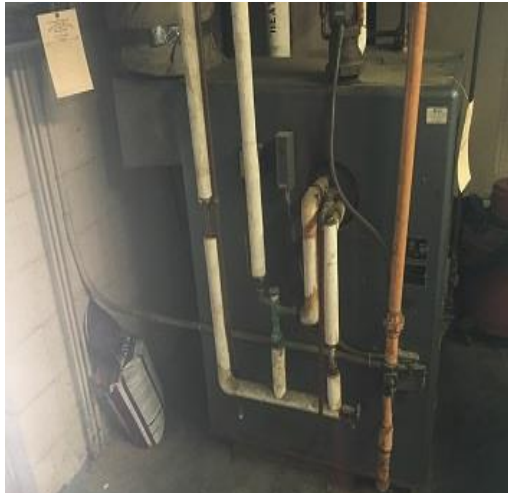
1. Mechanical (HVAC) Systems:
  - a. The HVAC system serving the building is a heating only hot water system consisting of a boiler, pump, piping, hot water base board, and unit heaters. The boiler, pump, and main distribution piping is located in the mechanical room.
    - 1) Boiler was manufactured by Weil-McLain CO. age unknown but appears to be past its life expectancy. Boiler is natural gas fired and has a maximum capacity of 288 MBH
    - 2) Building heating pumps appear to be in poor condition. Manufacturer, model number and age unknown.
    - 3) Main piping distribution in the boiler room is in poor condition. Piping insulation is discolored with age and is missing in many locations.
    - 4) Distribution piping located above the ceiling throughout the building is in fair condition. Piping insulation is in disrepair and missing in many locations.

1. Apparatus bay is unsafe and requires the following.
  - a. Installation of a gas detection system with CO/NO2 sensors and control panel.
  - b. Repair of the existing Apparatus bay exhaust system and integration into the new gas detection panel.
2. Replace existing boiler with new high efficient boiler.
3. Replace existing pump with new energy efficient pumps
4. Each space heating needs shall be calculated and the proper amount of heat shall be provided by new hot water heating elements. Repair, clean and/or replace existing heating elements and covers as required.
5. Repair existing piping insulation throughout the building.

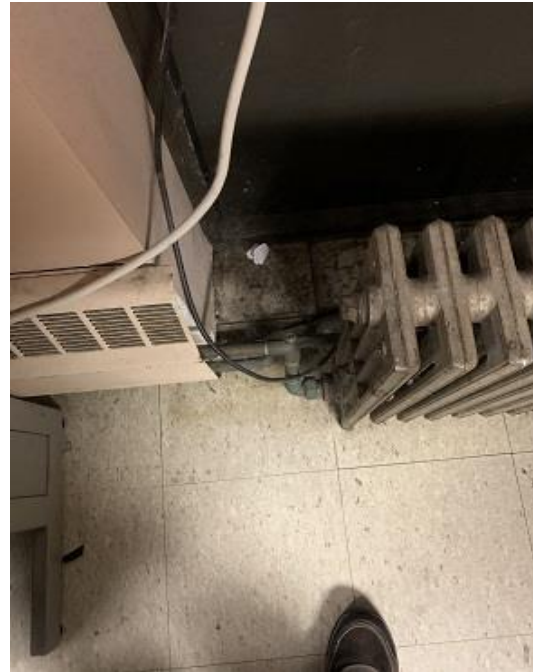
- b. Heating elements throughout the building are in poor condition.
  - 1) Baseboard heaters throughout the building are damaged and covers are missing in several locations. Heating elements are very dirty and covered with debris. In some places additional heating elements have been added in an attempt to properly heat spaces. Zone control valves and thermostats through the building are in various stages of disrepair.

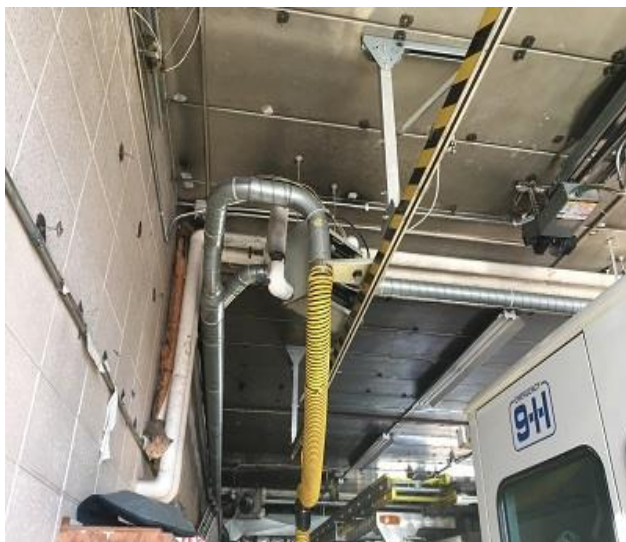
- 2) Building exhaust fans are in varies states of operation and disrepair.
  - a) Bathroom exhaust fans appear to be working properly.
  - b) Apparatus bay CO/NO2 emergency exhaust fan is operational and is controlled by space on/off switch.
- 3) Plymovent system is in good condition and is operational.

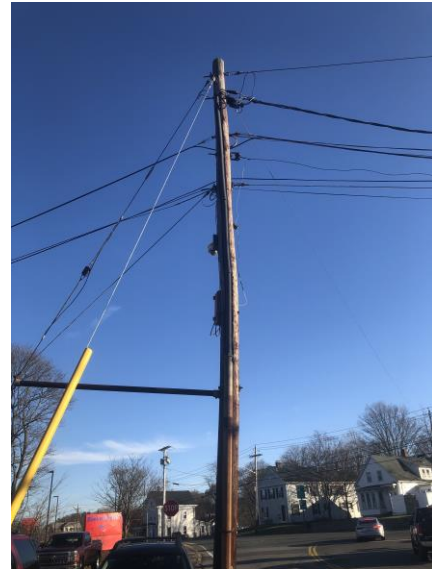
Utility Pole

1. The building is served by an underground electrical service fed via an existing utility pole which is located in the front of the Station along Rockland Street.

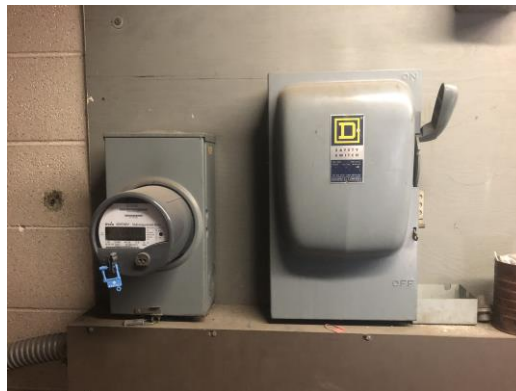
Utility Meter and Main Disconnect

2. The electrical service is rated 100 amperes, 120/208 volt, 3 phase, 4 wire. The main disconnect switch, utility meter, panelboard and automatic transfer switch are located within the building's mechanical-electrical room. The electrical service conductors are routed from the utility meter and main disconnect switch via a surface mounted wireway to the downstream panelboards and automatic transfer switch.

1. Upgrade the existing electrical service with new equipment sized to accommodate the facility's present and future needs. Estimated electric service size is 200 amps, 120/208V, 3 phase, 4 wire.

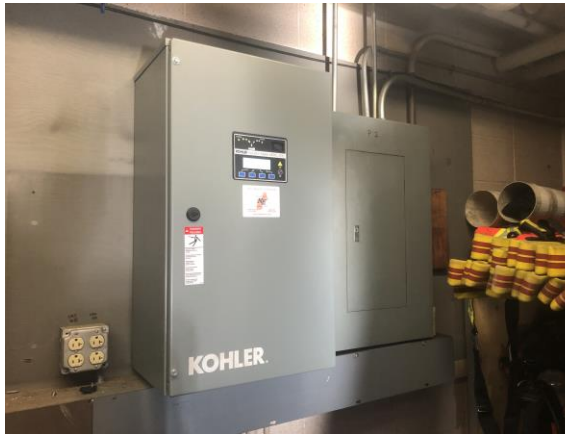
Automatic Transfer Switch

1. The building is equipped with a Kohler diesel fueled standby generator rated at 31.0kW/38.8kVA, 120/208 volt, 3 phase, 4 wire and is equipped with a single 100A output circuit breaker. The generator is pad mounted behind the building and is provided with a weatherproof enclosure and sub-base fuel tank. The generator's automatic transfer switch is located in the building's mechanical-electrical room. The generator and automatic transfer switch were installed within the past year and are in excellent condition.

2. The existing standby power system does not meet present code requirements with respect to fire separation of life-safety and standby systems.

7. Upgrade the existing standby generator and associated automatic transfer switch with new equipment sized and rated to support the building's new electrical service. The new generator is recommended to be a pad mounted, diesel fueled unit with weatherproof enclosure and sub-base fuel tank. Fuel tank capacity recommended to be sized for 72 hours of run time.

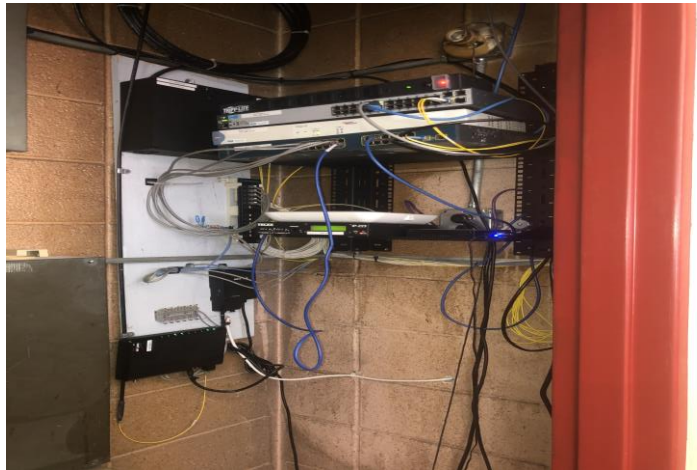
Equipment Rack

1. The telephone and data services to the building originate at the utility pole located in front of the Station along Rockland Street. Tel/Data services are routed overhead from this pole into the building's watch/dispatch room closet.
2. The building's tel/data equipment rack is located within a closet inside in the watch/dispatch room and appears to be in average condition.

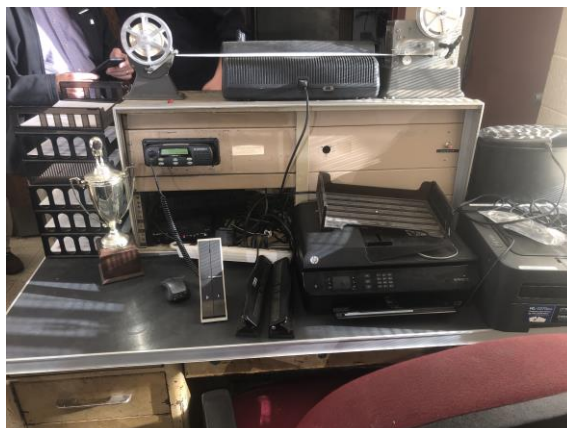
Dispatch System Console

3. It was noted that the dispatch system console located in the watch/dispatch room is mostly disassembled and non-functional.

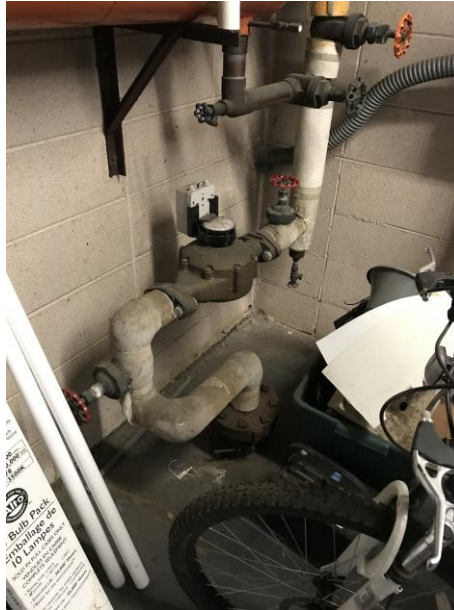
Water Serving Entrance & Water Meter

- a. The building is served by a 2” domestic water service that enters the Utility Room at the rear of the building off of Louds Ct. There is insulation on the service entrance so the size of the service is an approximation.

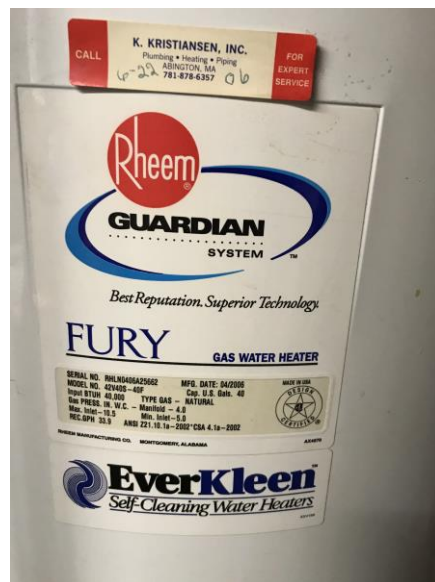
Water Heater Tag

- b. The building is served by a 1-1/2” gas main that also enters the building adjacent to the water service entrance.
- c. There is a 40 gallon gas water heater located in the Utility Room. There is no hot water return back to this water heater, and the water heater is approximately 100’ away from the buildings restroom and kitchen.

1. Remove existing water heaters. Provide new gas water heater and hot water return piping.
2. Provide all new low flow plumbing fixtures in restroom, per code.
3. Provide hose bibb in restroom, per code.
4. Verify sand and gas trap is in good working condition.
5. Provide new utility sink and reconnect to existing plumbing systems.
6. Provide reduced pressure backflow preventers on water service lines to the Gear Washer.
7. Provide thermostatic tempering valves for lavatories in the restroom.
8. Provide new public restroom with low flow fixtures. Provide 0.5 gpm faucet, and insulation on plumbing under the lavatory.

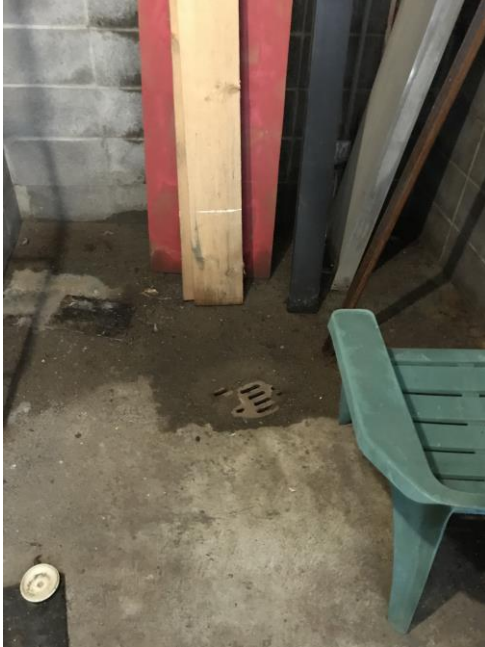
Floor Drain in Hose Tower

- d. There is a vertical reciprocating compressor in the mechanical room. The compressor appears to be in good working order.
- e. There is a floor drain located in the hose tower, this floor drain is packed full of sediment.

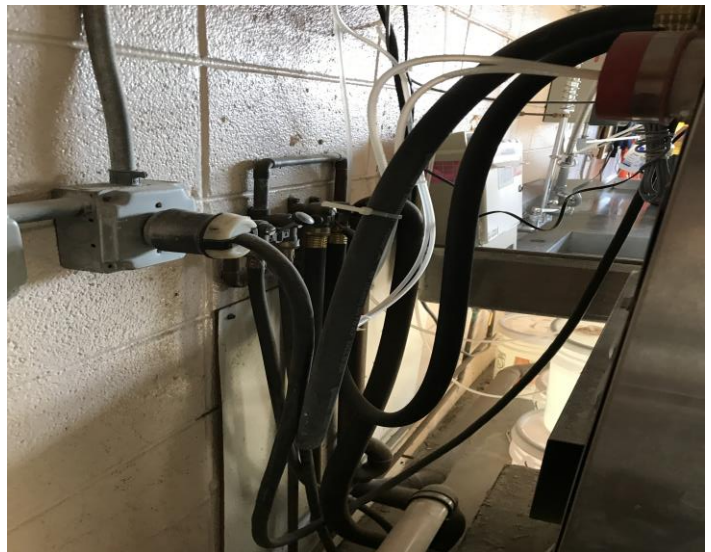
Gear Washer Water Connections

- f. There is a Gear Washer located in the Apparatus Bay. There was not any reduced pressure backflow preventers observed on water connections to the Gear Washer.

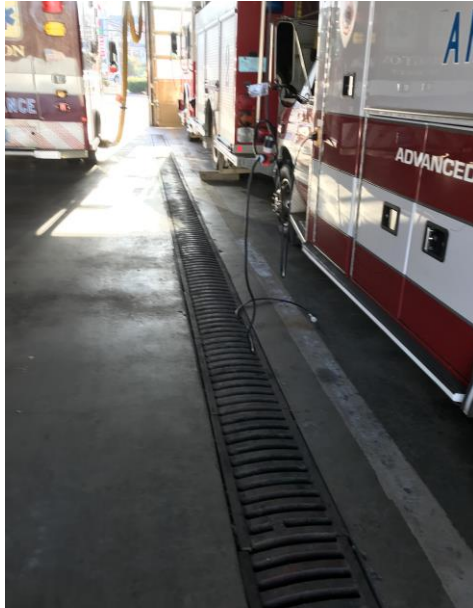
Trench Drain

- g. There is a trench drain in the Apparatus Bay. The trench drain appears to be discharging to a sand and gas trap located in the rear parking lot. The sand and gas trap appears to discharge to Louds Ct. Personnel were unaware of the sand and gas trap.

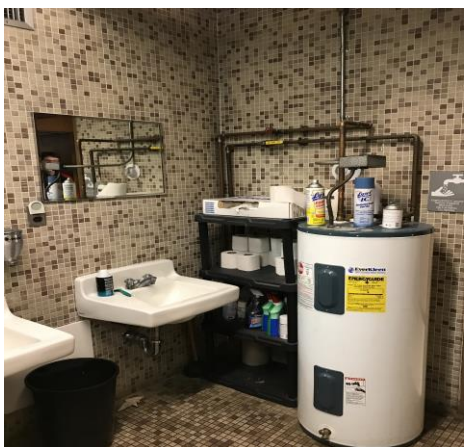
Water Heater & Lavatories

- h. The kitchen has a large sink and residential dishwasher.
- i. The restroom consists of two (2) wall mounted lavatories, one (1) wall mounted flush valve water closet, (1) shower, and one (1) floor drain. All fixtures in the restroom appear to be dated and are not low flow. There were not any thermostatic tempering valves observed at lavatories.
- j. There was not a hose bibb observed in the restroom, which is not code compliant.
- k. There is a 40 gallon 208 volt, single phase, 4.5 kw electric water heater located in the restroom. This water heater is fed from the gas water heater located in the Utility Room, and is used to boost the hot water to the kitchen and the restroom.

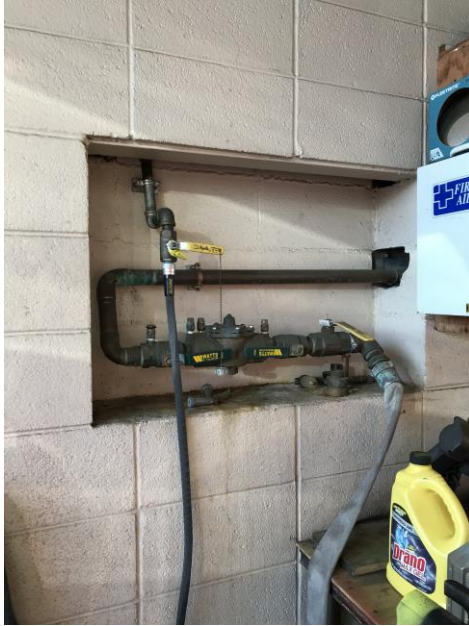
Truck Fill Valve

- l. There is a garden hose located in the Apparatus Bay.
- m. There is a 1-1/2" truck fill valve located in the Apparatus Bay that is fed from a 1-1/4" cold water feed.

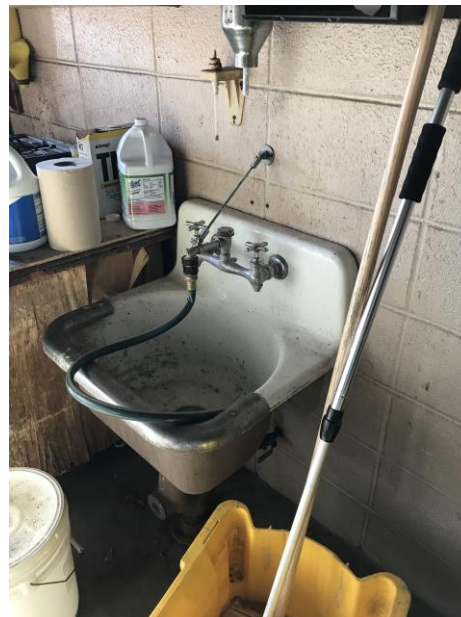
Utility Sink

- n. There is a wall mounted utility sink in the apparatus bay. The utility sink appears dated and worn.
