MECHANICAL

Existing Facility Evaluation

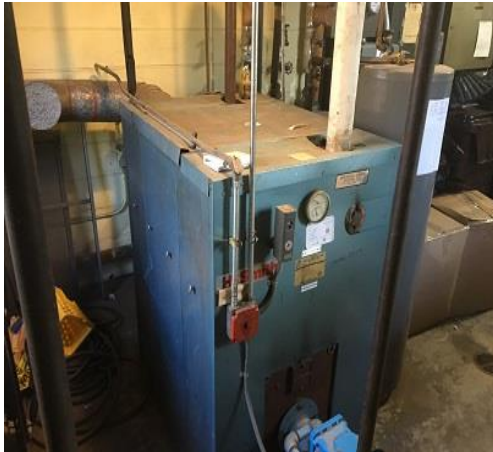
1. Mechanical (HVAC) Systems:
 - a. The HVAC system serving the building is a heating only hot water system consisting of a boiler, pumps, piping, and hot water base board. The boiler, pumps, and main distribution piping is located in the mechanical room.
 - 1) Boiler was manufactured by H. B Smith CO. in approximately May of 1989. Boiler is natural gas fired and has a maximum capacity of 480 MBH.
 - 2) Each of three (3) building heating zone has a dedicated pump. Pumps appear to be in poor condition. Manufacturer, model number and age unknown.
 - 3) Main piping distribution in the boiler room is in poor condition. Piping insulation is discolored with age and is missing in many locations.
 - 4) Distribution piping located above the ceiling throughout the building is in fair condition. Piping insulation is in disrepair and missing in many locations.

1. Apparatus bay is unsafe and requires the following.
 - a. Installation of a gas detection system with CO/NO2 sensors and control panel.
 - b. Repair of the existing Apparatus bay exhaust system and integration into the new gas detection panel.
2. Replace existing boiler with new high efficient boiler.
3. Replace existing pumps with new energy efficient pumps
4. Repair, clean and/or replace existing heating elements and covers.
5. Repair existing piping insulation throughout the building.
6. Repair/replace existing bathroom exhaust fans and controls.
7. The IT room unit exhaust duct should be rerouted to the building exterior.
8. Existing laundry dryer shall be properly exhausted to the exterior of the building.

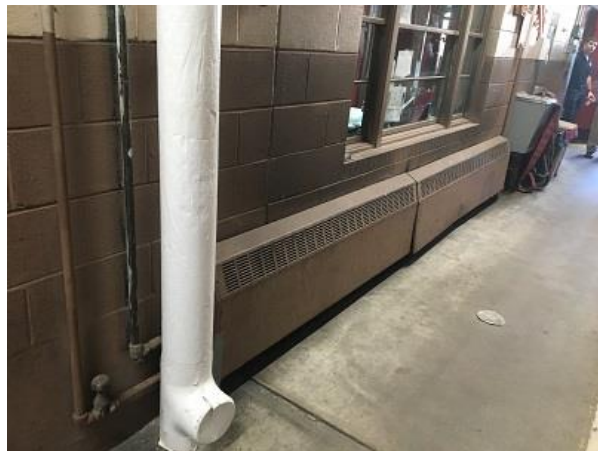
- b. Heating elements throughout the building are in poor condition.
 - 1) Baseboard heaters throughout the building are damaged and covers are missing in several locations. Heating elements are very dirty and covered with debris. Control valves and thermostats appear to be operational but are in poor condition.

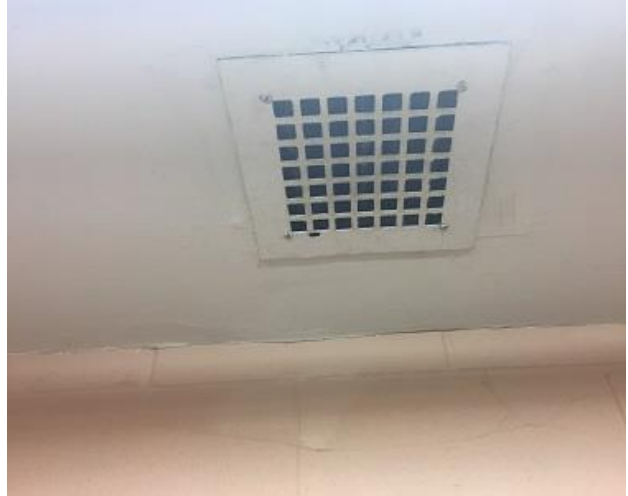
Bathroom Exhaust Grille

- 2) Building exhaust fans are in varies states of operation and disrepair.
 - a) Bathroom exhaust fans are not working.
 - b) Kitchen exhaust fan appears to be operating but at very low airflow. Fan is in poor condition.
 - c) Apparatus bay CO/NO2 emergency exhaust fan is operational and is controlled by space on/off switch.

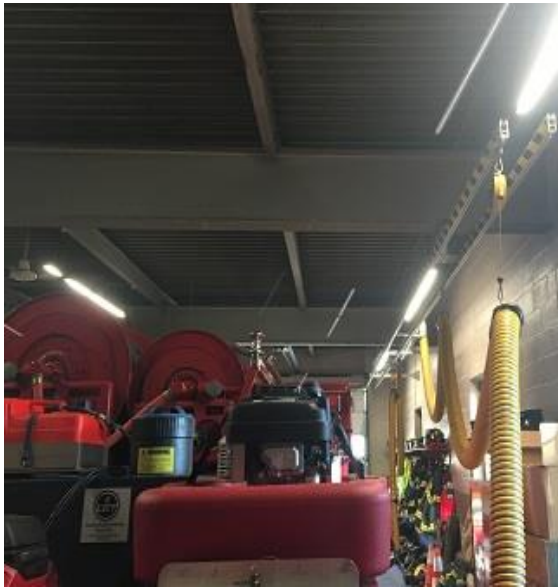
Plymovent System

- 3) Plymovent system is in good condition and is operational.

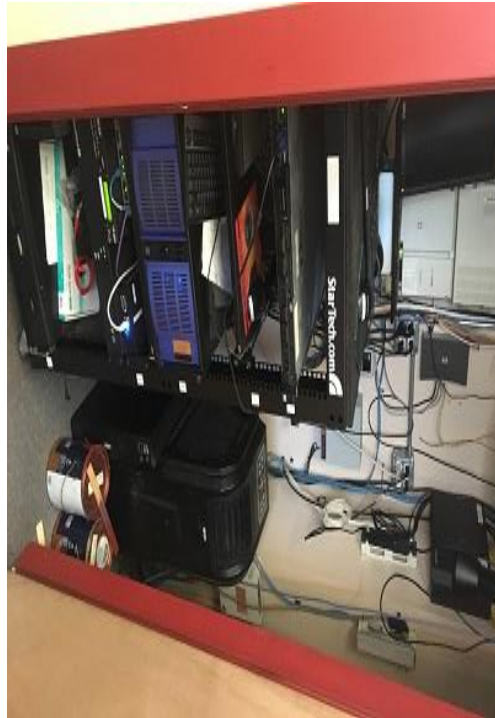
IT Room

- 5) It room is located in the chiefs closet and is cooled by a roll away unit. Unit is currently exhausted to the apparatus bay. Unit appears to be in poor condition.

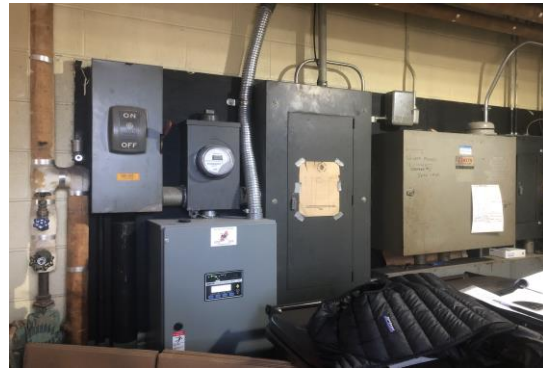
Electrical Panels

3. The building is equipped with a main electrical panel and several smaller downstream branch panelboards. The panelboards are located at several locations throughout the building including the mechanical-electrical room, the apparatus bay, and the second floor corridor. Most panelboards and disconnect switches appear to be original to the building's construction and are beyond their anticipated useful life.

2. Remove and replace existing electrical panelboards with new equipment to provide capacity for all present and anticipated future equipment loads plus additional spare capacity.

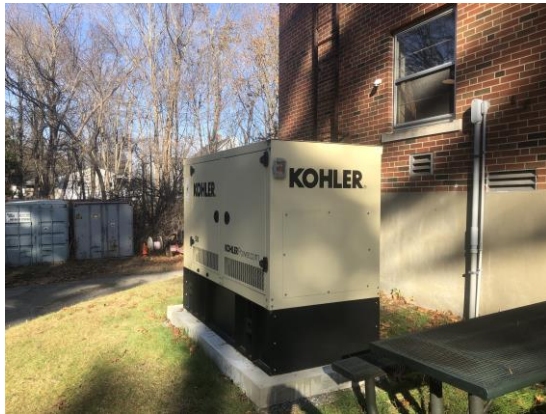
Standby Generator

1. The facility is equipped with a Kohler diesel fueled standby generator rated at 50kW/50kVA, 120/240 volt, 1 phase, 3 wire and is equipped with a single 200A output circuit breaker. The generator is pad mounted behind the building and is equipped with a weatherproof enclosure and a sub-base fuel tank.
2. The generator's automatic transfer switch is located in the building's mechanical-electrical room. The generator and automatic transfer switch were installed within the past year and are in excellent condition.

3. The existing standby power system does not meet present code requirements with respect to fire separation of life-safety and standby systems.

7. Remove exterior type SO cord serving trailer in rear parking lot and install permanent power by a code approved method (conduit and wire).
8. Remove the existing standby generator and associated transfer switch and replace with new equipment sized and rated to support the facilities upgraded electrical service (amperage and voltage). New generator is recommended to be diesel fueled and be pad mounted with weatherproof enclosure and sub-base fuel tank. Fuel tank capacity recommended to be sized for 72 hours of run time.

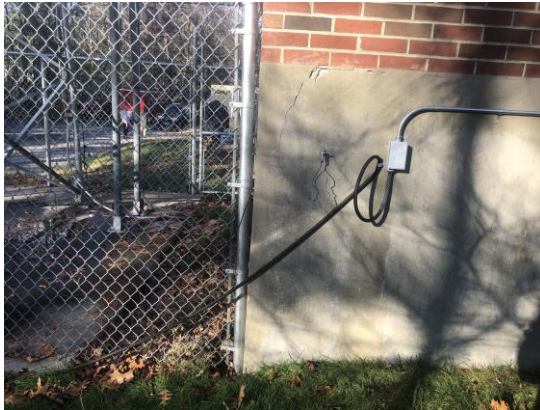
SO Cord

1. In general, there are grounding type duplex receptacles installed in all areas with GFCI receptacles located as required by code. The devices appears to be in average condition.
2. Branch circuit wiring observed consists of conductors installed in conduit or type MC cable. A length of type SO cord is being used to serve a fire department support trailer located in the rear parking lot which is a code violation as the cord is being used as a substitute for fixed wiring.

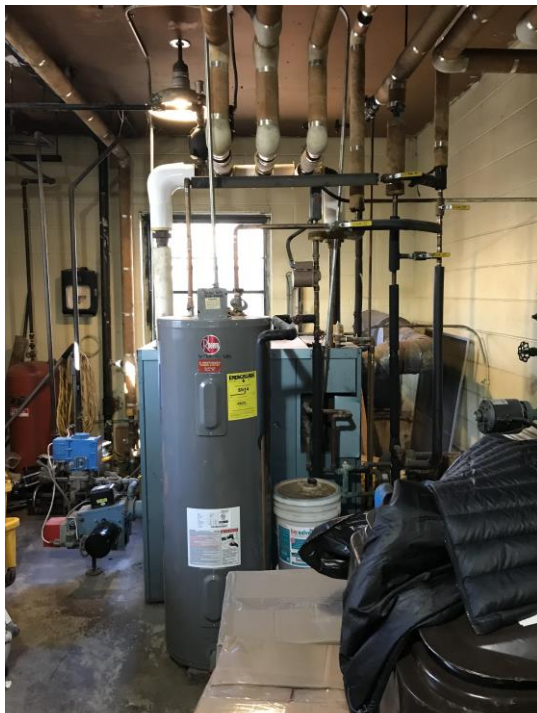
Electric Water Heater

- b. The building is served by a 2-1/2" gas main that enters the building adjacent to the water main. This gas main currently only serves the boiler.
- c. There is a 50 gallon, 240 volt, single phase, 6kw electric water heater within the mechanical room. All fixtures were adequately receiving hot water.

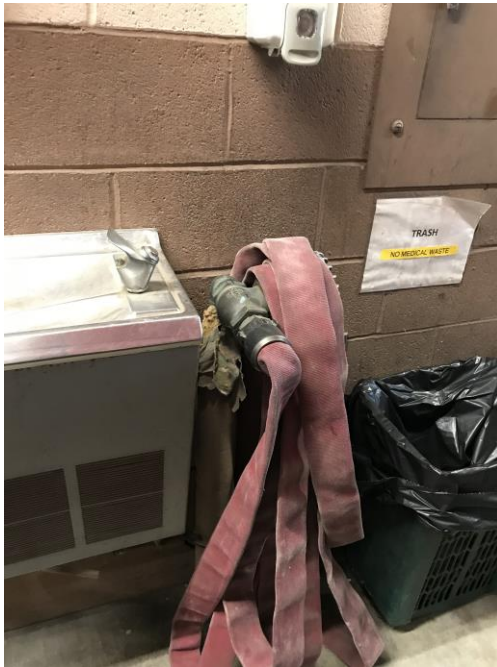
Truck Fill Valve and Drinking Fountain

- e. There are two (2) 1-1/2” truck fill valves located in the apparatus bay.

- i. There is a drinking fountain in the Apparatus Bay. The drain for this sink is no longer connected to the sanitary waste system.
- j. The public restroom on the first floor consists of a floor mounted flush valve water closet, a wall mounted lavatory, and a floor drain. There is not any insulation on plumbing under lavatory.

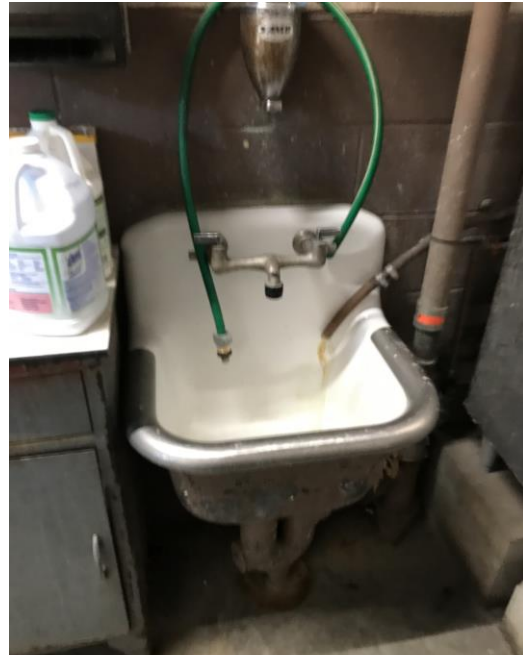
Utility Sink

- f. There are not any floor drains in the Apparatus Bay.
- g. There is a clothes washer in the Apparatus Bay.
- h. There is a utility sink in the Apparatus Bay. This sink is worn, but still functioning.

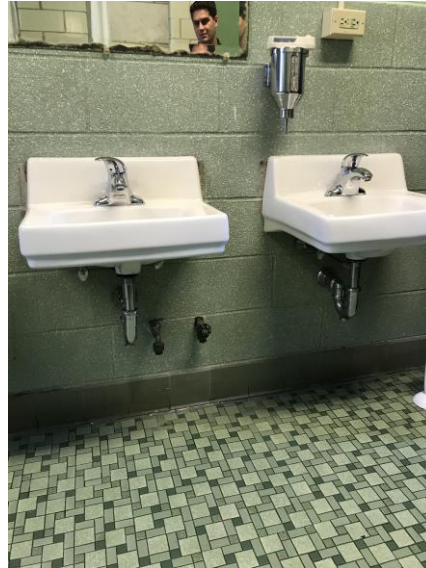
Second Floor Lavatories

- k. The second floor restroom consists of a floor drain, two (2) hose bibbs, three (3) wall mounted lavatories, two (2) urinals, two (2) showers, and two (2) wall mounted water closets with flush valves. The Fire Department reports leaking from the urinals and the floor drain. One (1) of the hose bibbs with in the bathroom does not work.

- l. No thermostatic mixing valves were observed at any lavatories.

1. Provide trench drains in Apparatus bay to meet current code. Provide sand and gas trap for new trench drains, and connect to the sanitary main exiting the building.
2. Remove the existing plumbing fixtures in the second floor restroom, and provide new low flow fixtures.
3. Remove the existing plumbing fixtures in the first floor restroom, and provide new low flow fixtures.
4. Provide thermostatic mixing valves on all lavatories.
5. Remove existing utility sink in Apparatus Bay, and provide new utility sink and reconnect to existing plumbing systems.
6. Remove existing drinking fountain, and provide new drinking fountain and reconnect to existing plumbing systems.
7. Provide two (2) new roof drains with integral overflow drains in place of existing roof drains. Provide new overflow piping to daylight, and reconnect new roof drains to existing rain water piping.
