MECHANICAL

Existing Facility Evaluation

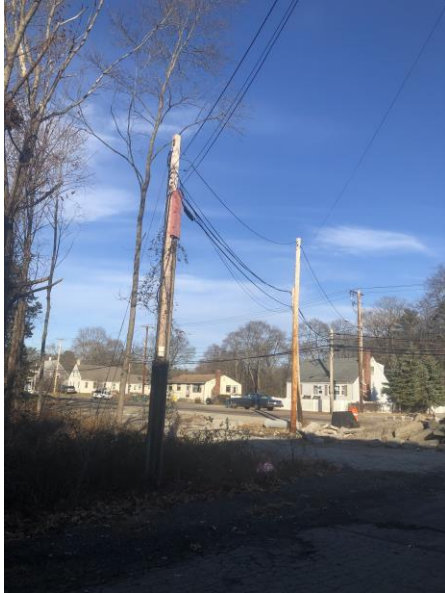
Existing Utility Pole

1. The building is served by an underground electrical service fed via an existing utility pole which is located adjacent to the north-east end of the property.

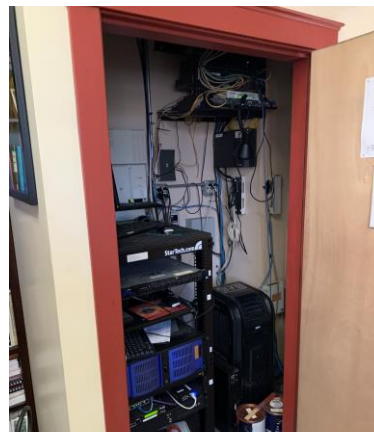
Tel/Data Equipment Rack

1. The telephone and data services to the building originate at the utility pole located at the north-east corner of the property. Tel/Data services are routed overhead from this pole into the building's watch/dispatch room and is distributed from this location to rack mounted equipment in the Chief's office closet.
2. The building's tel/data equipment rack is located at the south-west corner of the building with a closet inside the Chief's office. The central fire alarm monitoring/receiving equipment for the Town's master boxes is located within the control room.

3. A large communications antenna is located behind the building and serves the station's radio and emergency communications systems.
4. In general, tel/data and radio communications systems wiring adequately serves the facility's needs. Much of this wiring has been installed surface mounted.

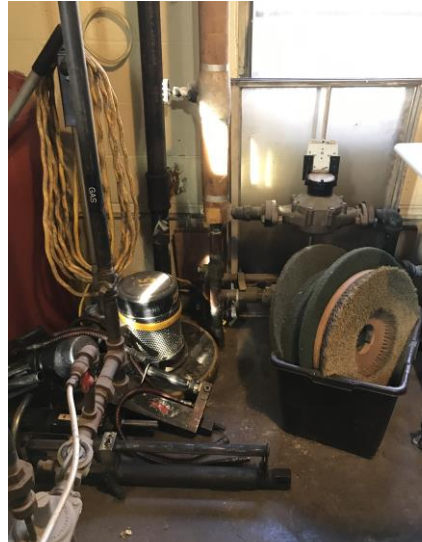
Water Main Entrance

- a. The building is served by a 1-1/4" cold water service that enters at the rear of the building in the mechanical room.

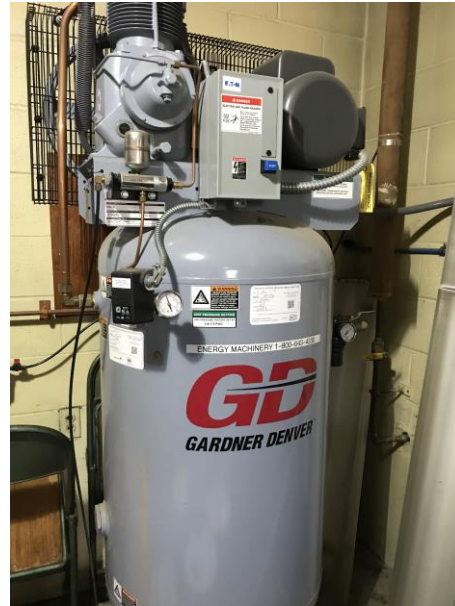
Vertical Reciprocating Compressor

- d. There is a vertical reciprocating compressor in the mechanical room. The compressor appears to be in good working order.
