ABINGTON FIRE STATION FACILITY STUDY

Existing Conditions Structural Report - Station No. 1

December 22, 2019 - DRAFT

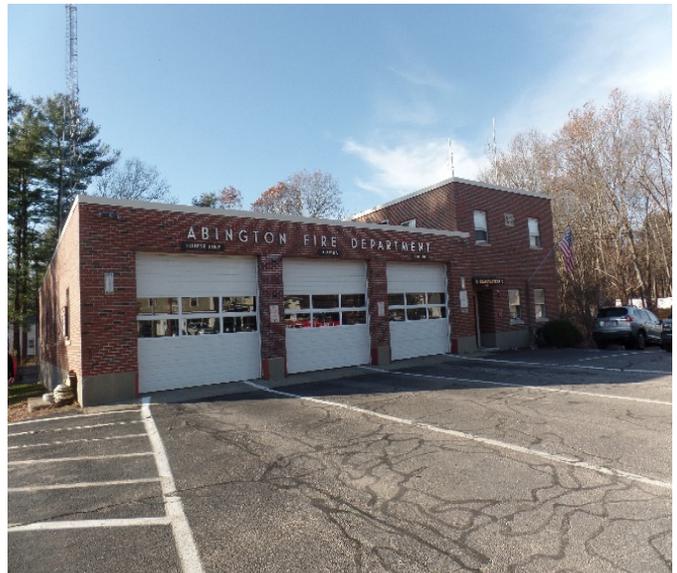
Fire Station No. 1 is located at 1040 Bedford Street in Abington, MA. Constructed in 1964, it is the older of the two fire stations in the Town, and serves as the headquarters for the department. The two-story building is rectangular in plan, with (high and low) flat roofs. Three (3), single-depth apparatus bays are located on the First Floor of the facility, accessed by overhead doors on the east (front) side. The main entrance to the building is located on the east side as well. A partition separates the apparatus bays from the administration area at the back of the station. Support spaces at the First Floor (rec room, utility/storage room, offices, etc.) are located along the north side of the building, below the (partial) Second Floor. This area is separated from the apparatus bays by a 12" thick concrete block (east-west) bearing wall. The Second Floor is served by single, wood framed stairway; bunk rooms and a bathroom are located at this level. Station No. 1 has no Basement. There have been no significant renovations or additions to the building since the original construction.
