ABINGTON FIRE STATION FACILITY STUDY

Abington, Massachusetts

Existing Conditions Structural Report - Station No. 2

December 22, 2019 - DRAFT

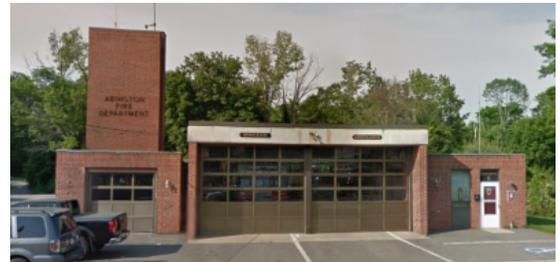
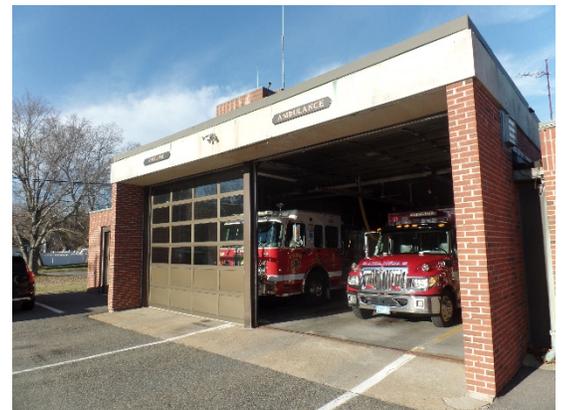
Station No. 2 is a one-story building with high and low flat roofs. Roof construction over each wing consists of precast, prestressed concrete plank supported by CMU bearing walls. It appears that there are parapets at limited locations in each wing (and at the hose tower, where a scupper was observed).

First Floor construction appears to be a concrete slab on grade.
